Wasa Lake Preliminary Water Quality and Sediment Quality Assessment

Prepared for Wasa Lake Land Improvement District
Winter 2026

Report prepared by: Larratt Aquatic Consulting Ltd.

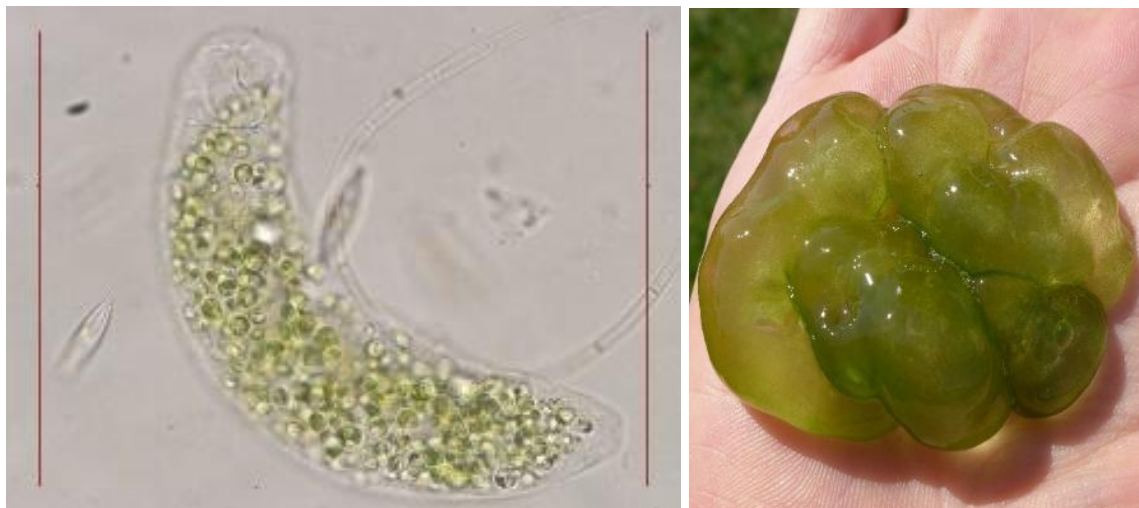
Figure 7: *Ophrydium* cell under the microscope with green algae within it and *Ophrydium* colonies visible to the naked eye

May 30 samples contained dense colonies of *Ophrydium* ciliates forming a gelatinous mucilage. *Ophrydium* is a freshwater protozoan commonly found in wetlands and lakes, where it forms large colonies that appear as gel spheres in the water column. These spheres are typically clear, but *Ophrydium* appeared green in Wasa Lake because green algae were symbiotically within the gel spheres (Figure 7; Table 4). *Ophrydium* gel spheres do not pose a risk to recreator health.

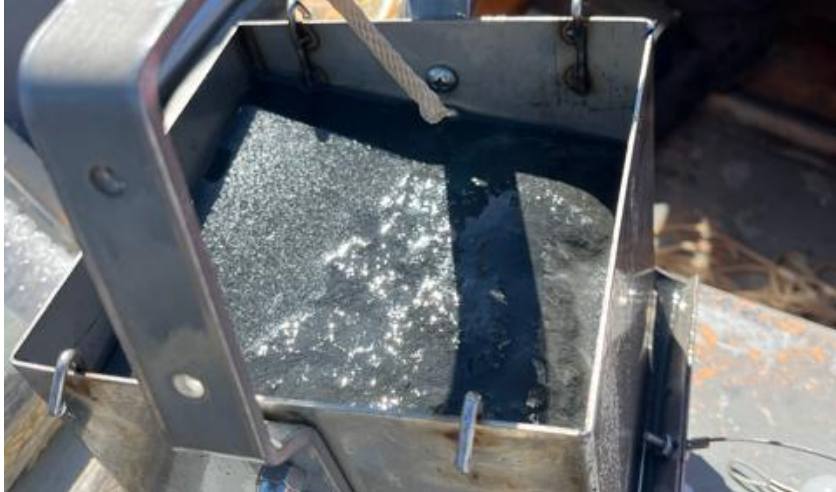
Figure 9: Sediment sample from Wasa Lake's South Bay, May 30, 2025

Lake sediments from the North, South and Central bays were analyzed for extractable petroleum hydrocarbons (EPHs) and total metals² (Figure 1). Sediment samples across all sites were similar in composition, appearing grey in colour and containing hydrocarbon and sulfur odors (Figure 9).

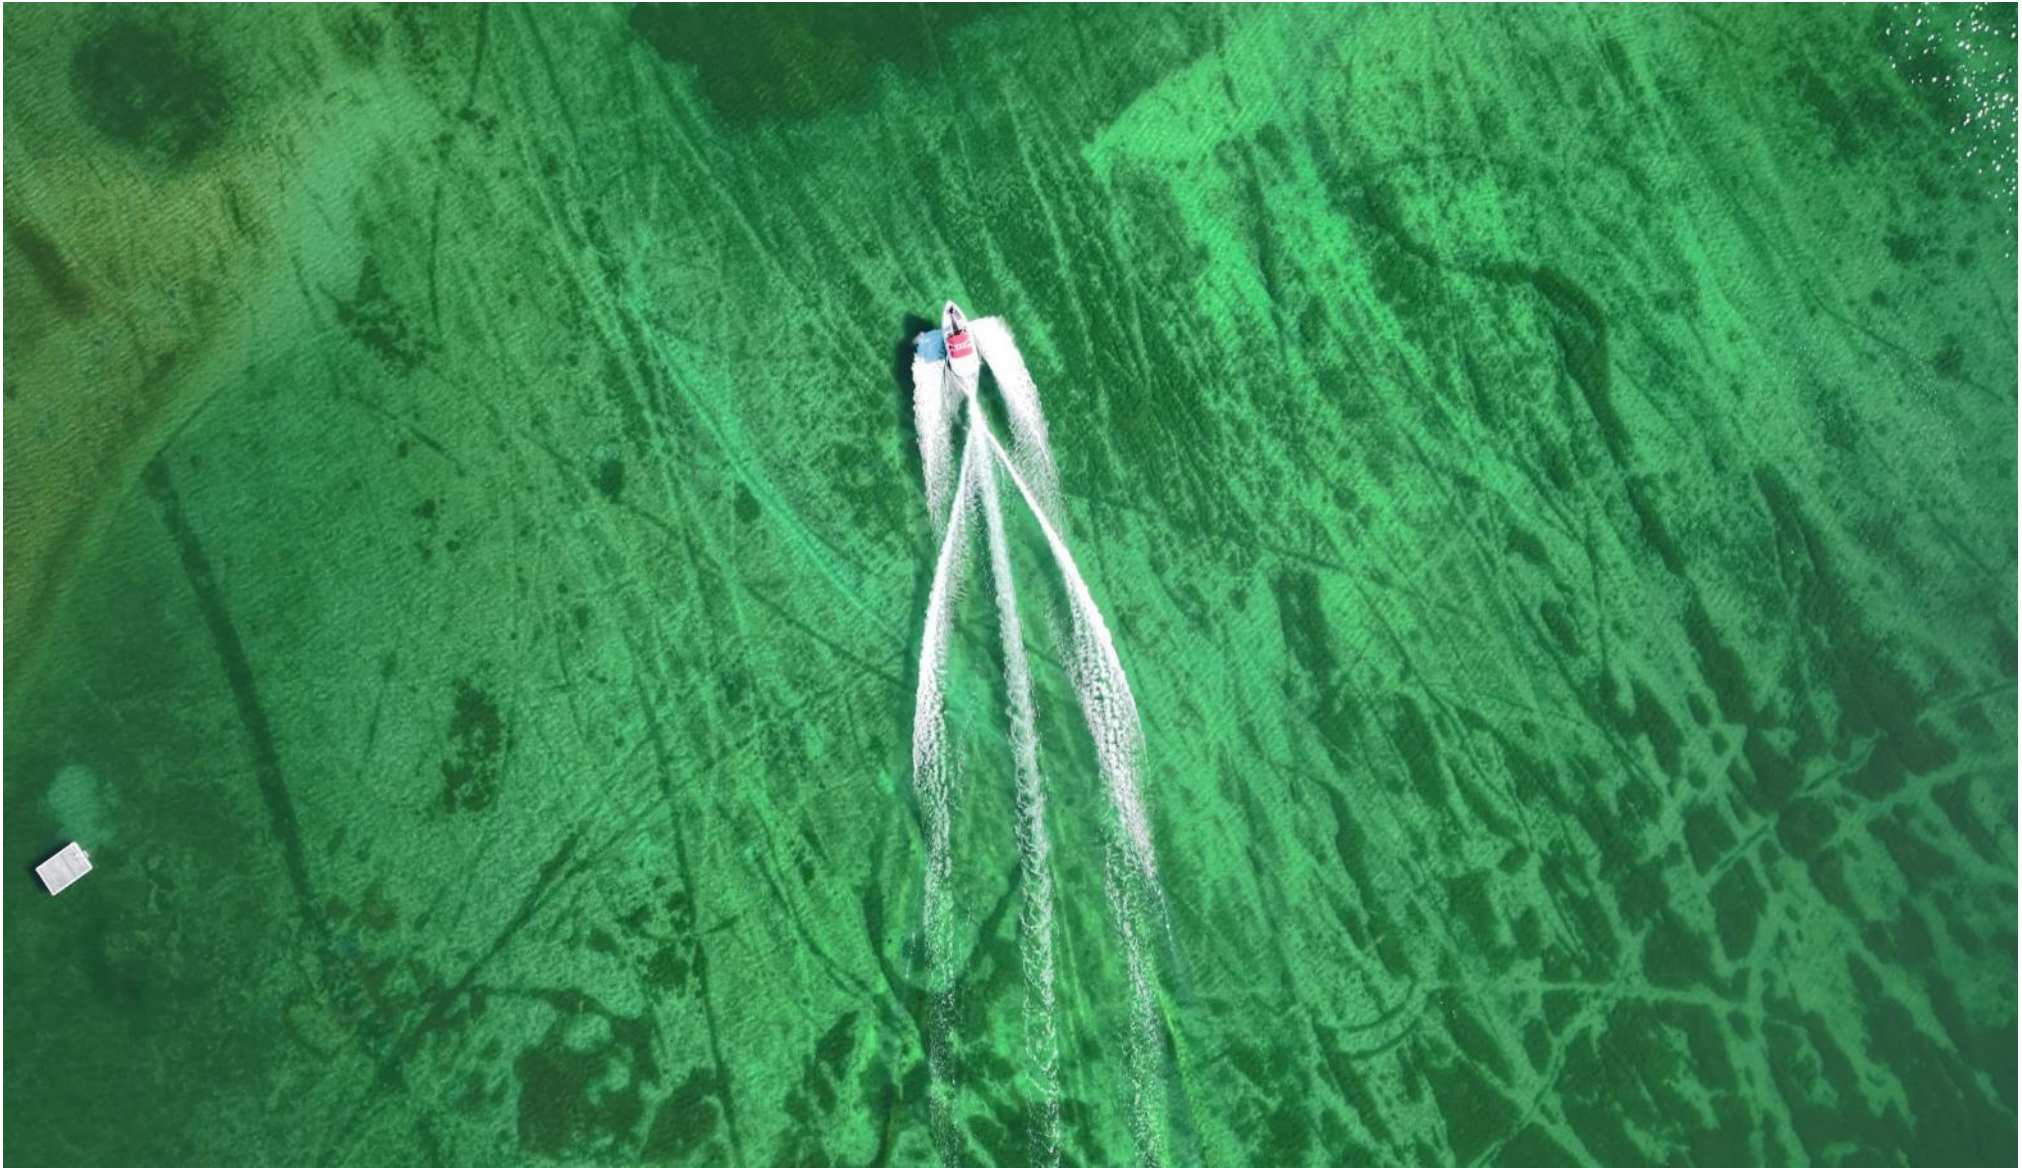
Figure 11: Extensive sediment scouring caused by boating, May 30, 2025

Aerial drone footage collected for this study by Bailey Repp recorded evidence of abundant boat impacts to Wasa Lake’s sediment (Appendix 3: Drone Footage). Wasa Lake’s average depth of only 3.8 m increases the risk of sediment disturbances caused by boating. Extreme sediment disturbances caused by boating can cause deep scours/trenches in a lake’s bottom (Figure 10). Wasa Lake’s sediment contained deep trenches and scours caused by boat propellers in each bay (Figure 11).

Formation of trenches causes large-scale sediment disturbances, increased turbidity, and mobilization of contaminants, nutrients and *E. coli* from the sediment into the water column, degrading water quality. Sediment resuspension negatively influences aquatic life by reducing light penetration, influencing fish feeding and schooling, causing gill irritation and damage to fish’s protective eye mucous, disturbing fish eggs, and dislodging benthic invertebrates from the sediment (Environment and Climate Change Canada, 2017). Disturbed sediments also influence ecological dynamics and can stimulate algae growth from increased nutrient availability in the water column (Dillon et al. 1990; Nedohin and Elefsiniotis 1996).

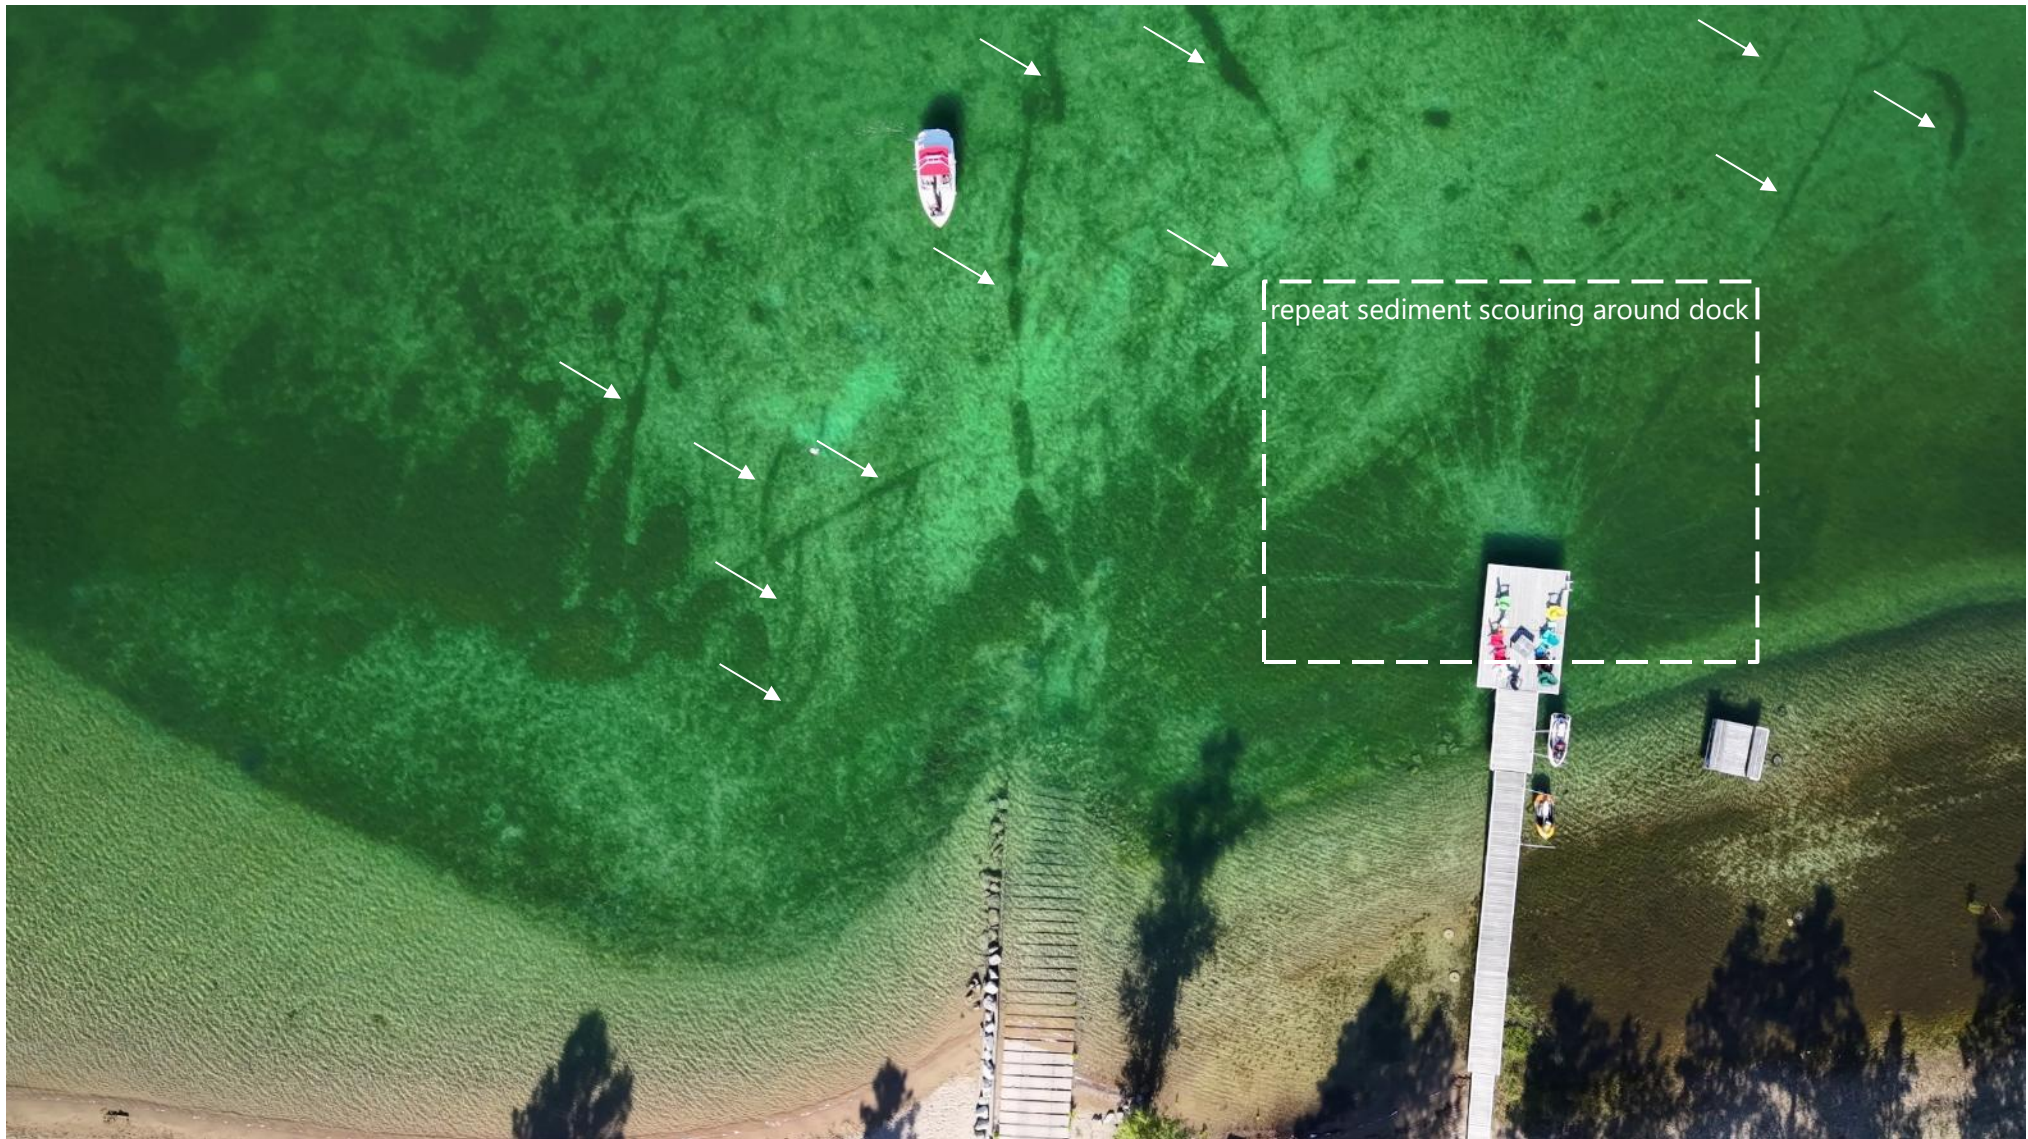
Figure 13: Sediment scouring at Wasa Lake Provincial Park's boat launch, 2025
Note: Arrows and boxes indicate some scours/trenches
